October 1945 as
Memorandum Report A5J19a

A FLIGHT INVESTIGATION OF THE ICE-PREVENTION REQUIREMENTS OF
THE UNITED STATES NAVAL K-TYPE AIRSHIP

By Wesley H. Hillendahl

Ames Aeronautical Laboratory
Moffett Field, California

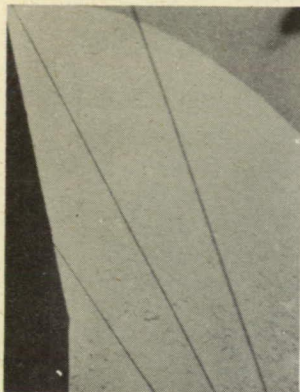
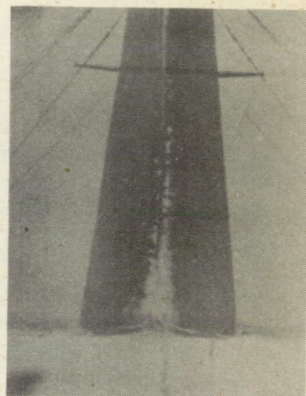
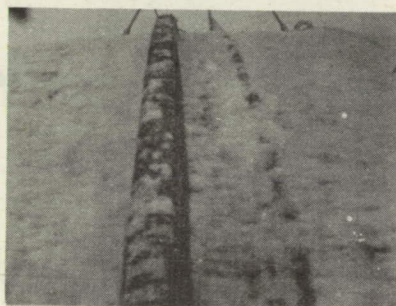
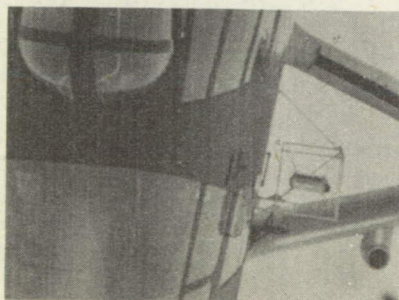
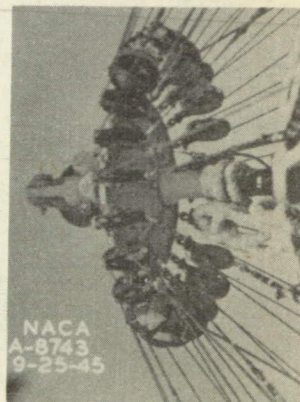
An idea of the extent of the snow accumulated on various parts of the airship while on the ground and during the first 5 minutes of flight may be obtained from figure 16. The camera numbers correspond to those appearing in figures 4 and 5. Of the 12 cameras the records of cameras 3 and 7 are omitted. Camera 3 failed to operate properly and camera 7 showed no ice or snow to accumulate on the port helium valve at any time during the flight. At 1:50 p.m., when figure 16 was taken, heavy snow was falling and the propeller blade shoes were operating. Shortly after 2:00 p.m. the airship reached pressure height at 2000 feet.

The series of photographs of the envelope and fins starting with figure 16 show, however, that as soon as the airship attained cruising speed the wet snow began to blow and melt off, even though the airship was flying almost continually in snow during the entire flight. The only notable exceptions to this tendency on the envelope were the regions at the stern and bow scanned by cameras 1 and 12, respectively. Even though the snow which had accumulated in these regions before take-off continued to build up throughout the flight, the airship did not become difficult to control at any time.

Figure 16.- Condition of the K-24 airship envelope, fins, and car at 1:50 p. m., Mar. 22, 1945; 5 minutes after take-off.

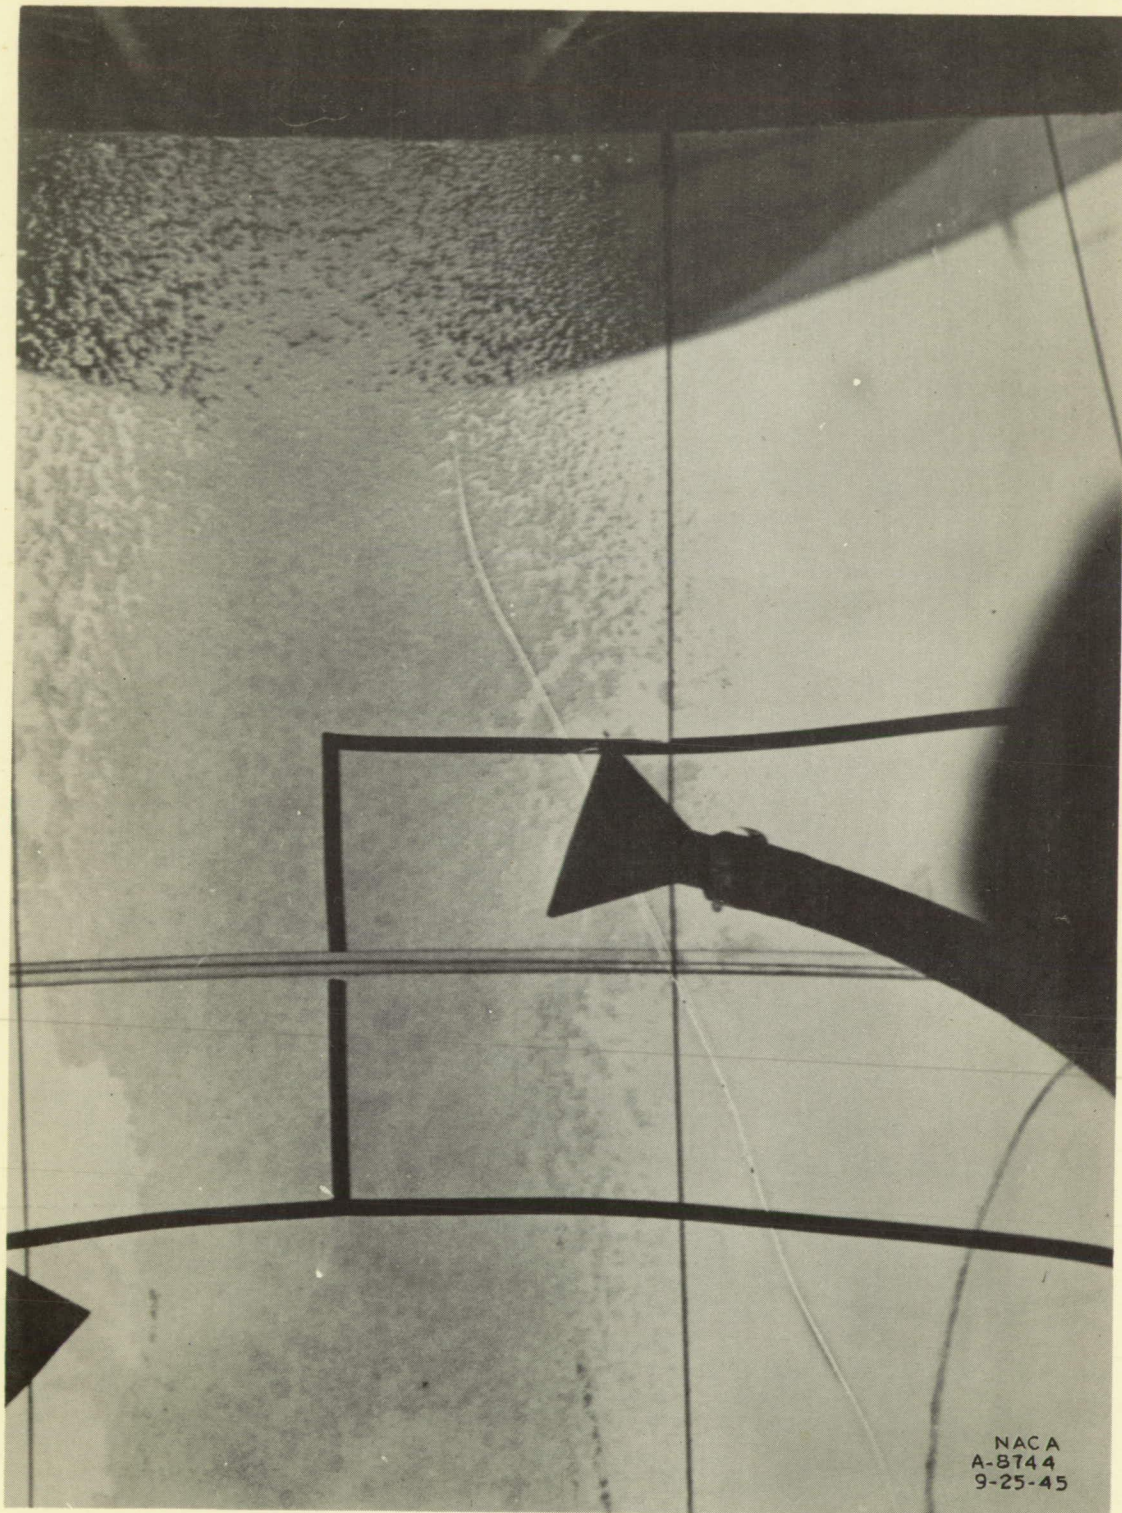
The forward windshield was clear of ice upon take-off but the accumulation shown in figure 17, taken at 2:05 p.m., gradually became thicker and more extensive as the flight progressed. The ends of the heated-air ducts directed at the inner surface of the windshield may be seen in the lower half of the figure.

The amount of ice accumulated on the windshield in flight indicates the desirability of an adequate windshield ice-prevention system. The system installed for the reported tests was of very limited effectiveness.

Figure 17.- Ice on the forward window of the K-24 airship car at 2:05 p. m., Mar. 22, 1945.

3. The installation of an adequate windshield ice-prevention system is very desirable.

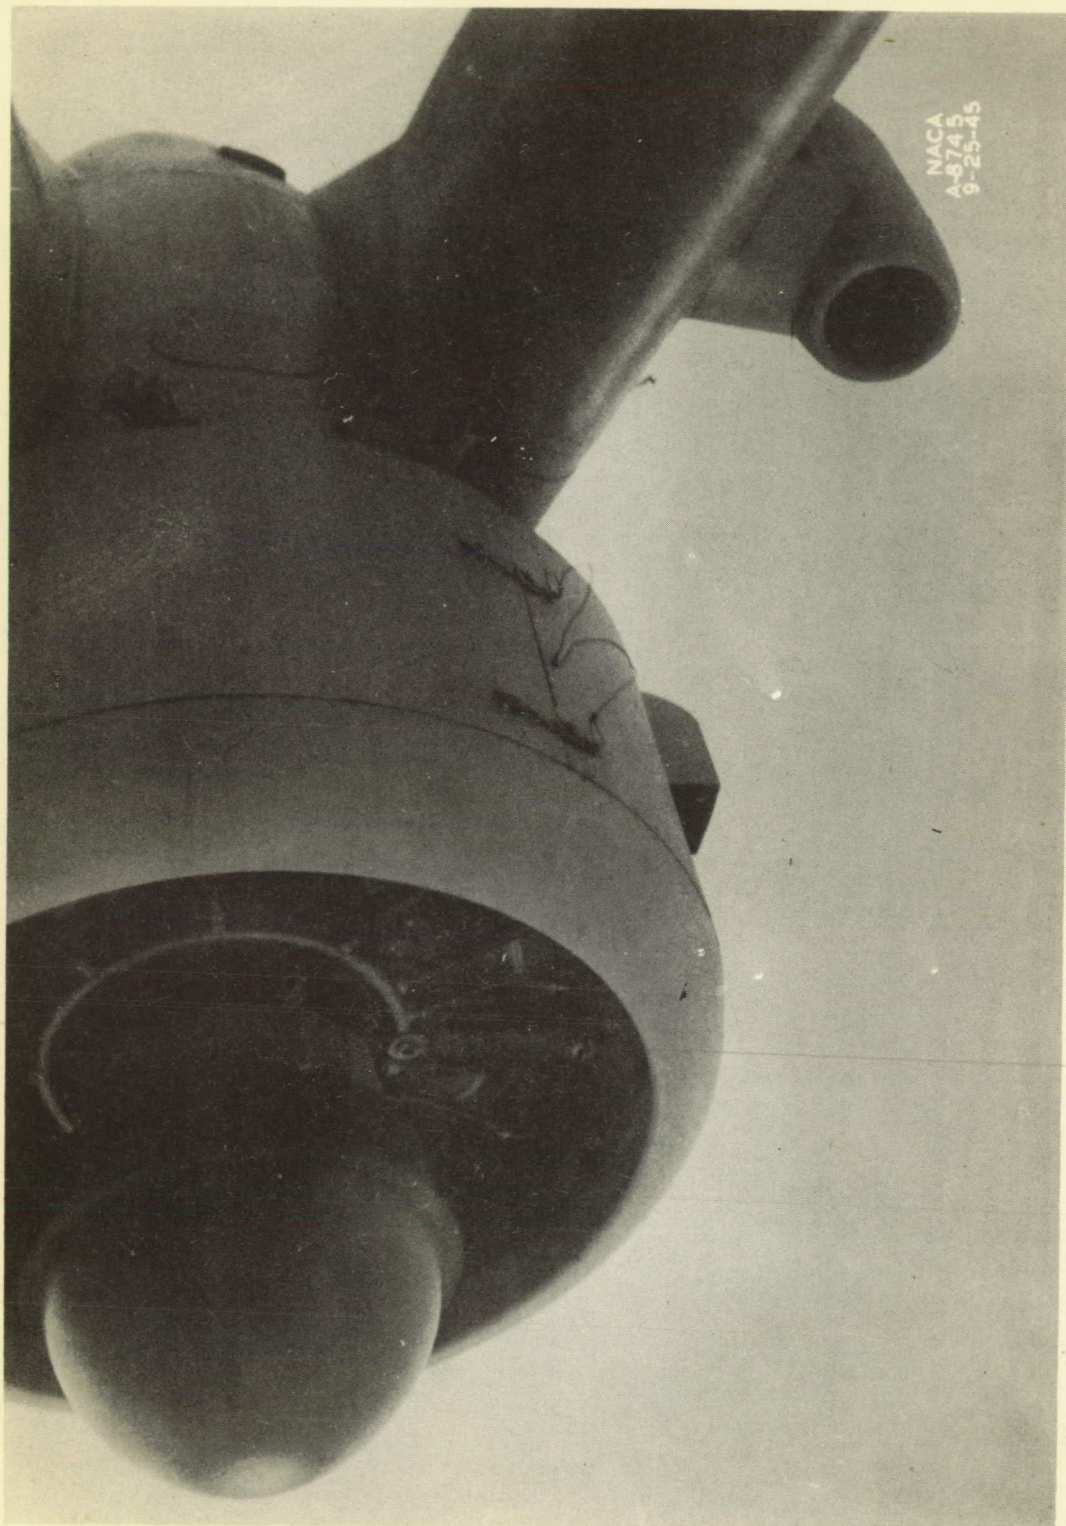
Figure 18 taken at approximately the same time shows ice accumulating on the leading edge of the oil-cooler air scoop, outrigger, and propeller spinner. At this time the airship was flying with the aft ballonnet empty and 8° down-elevator

at an airspeed of 55 knots. This airspeed was maintained throughout the flight. Visibility was zero and heavy snow and rain were falling. The aerograph had collected a thin coat of glaze ice.

Figure 18.- Ice on the starboard engine outrigger of the K-24 airship at 2:06 p. m.,
Mar. 22, 1945.

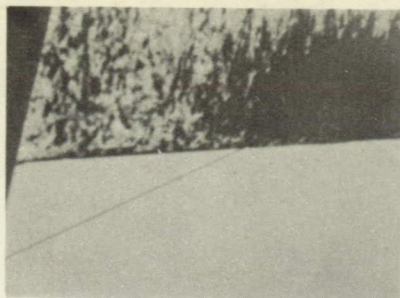
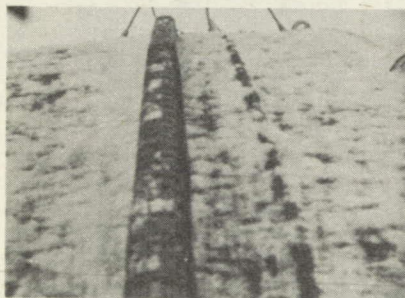
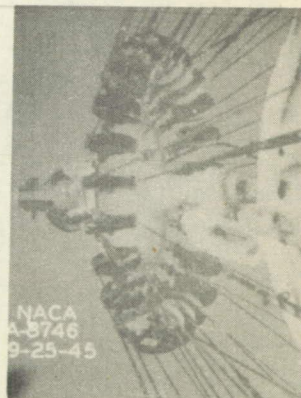
The snow accumulated on the top of the envelope and fins while on the ground is shown in figure 19, taken at 2:32 p. m., to be gradually thinning out. In the regions scanned by cameras 1, 8, 9, and 12 at the stern, car, and bow, snow and ice were building up slowly.

Figure 19.- Condition of the K-24 airship envelope, fins, and car at 2:32 p. m., Mar. 22, 1945.

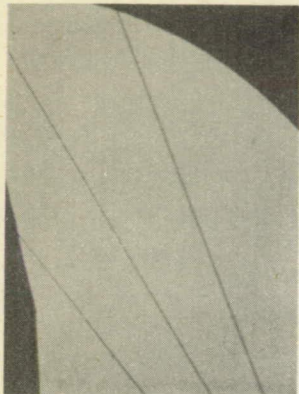
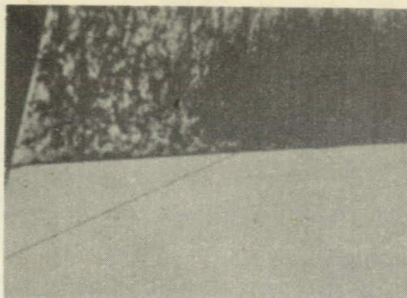
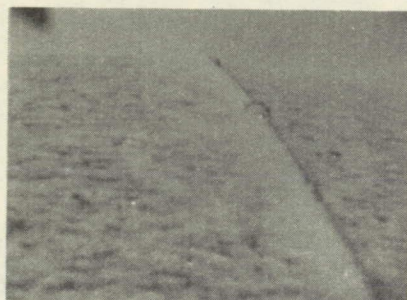
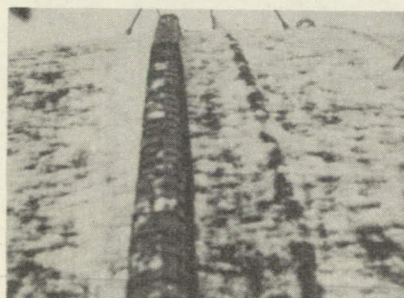
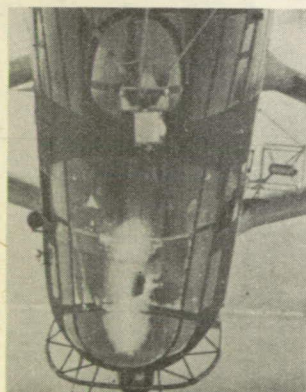
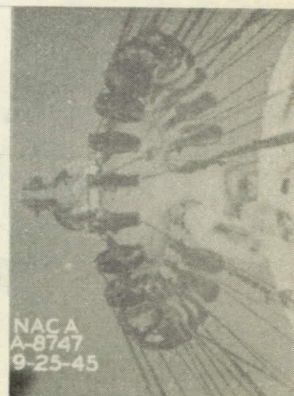
Figure 20, taken an hour after take-off, shows a continuation in the trends shown in the previous set of photographs taken 13 minutes earlier. The airship flew into a rain shower after these photographs were taken and the condition of the airship a minute later is shown in figure 21. The effect of the rain is most apparent in the records of cameras 2, 4, 10, and 11.

Figure 20.- Condition of the K-24 airship envelope, fins, and car at 2:45 p. m., Mar. 22, 1945.

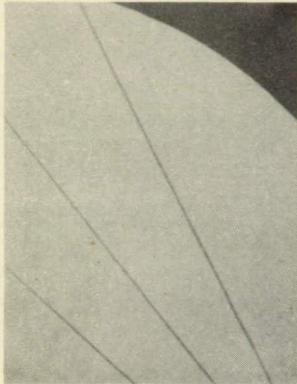
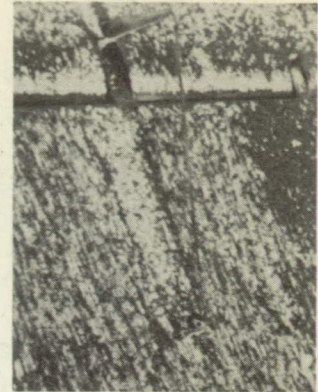
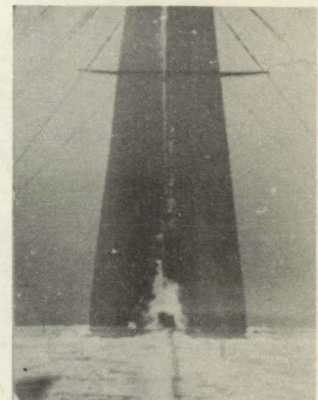
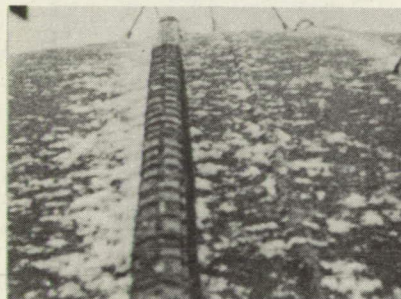
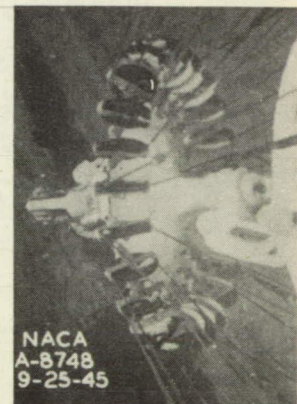
Figure 21.- Condition of the K-24 airship envelope, fins, and car at 2:46 p.m., Mar. 22, 1945.

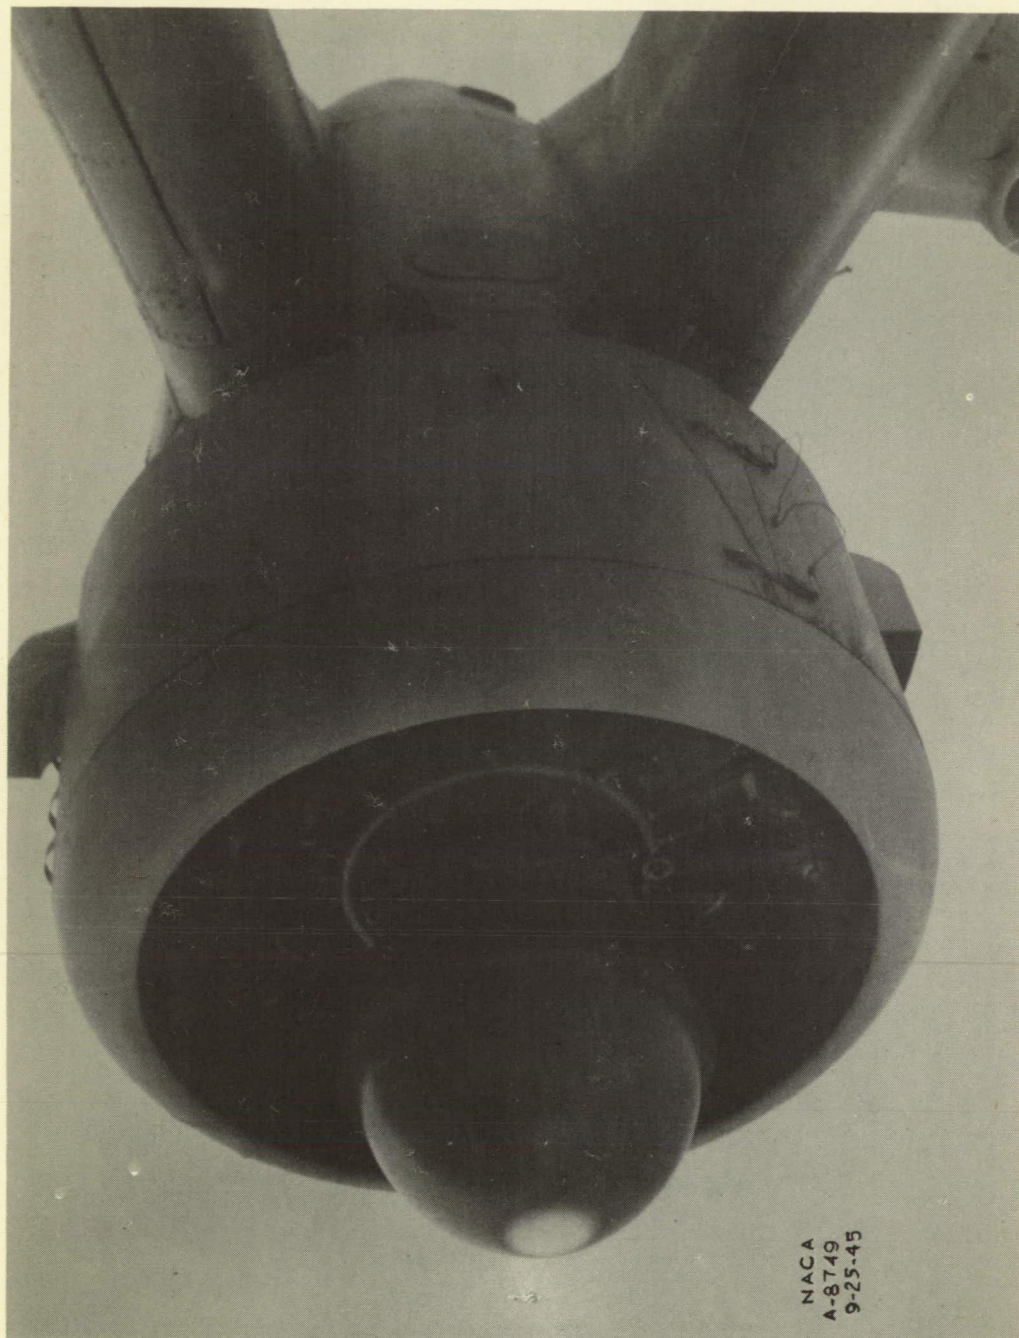
At 3:01 p. m. the amount of ice on the engine outriggers, shown in figure 22, is about the same as it was an hour before. (See fig. 18.). The airship was flying at 55 knots airspeed with 10° down-elevator, 2° up-inclination, and aft ballonnet empty.

The accumulation of snow and ice on the engine outriggers, fin leading edges, and similar locations are not considered serious since they neither interfere with the operation of the airship nor add appreciably to its weight.

Figure 22.-- Ice on the K-24 airship outrigger at 3:01 p. m., Mar. 22, 1945.

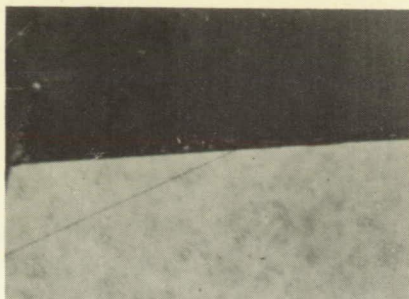
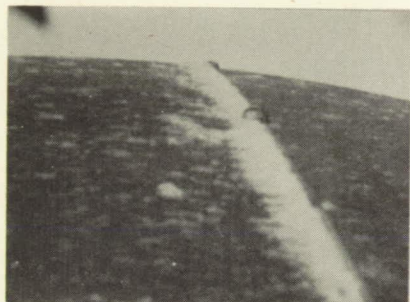
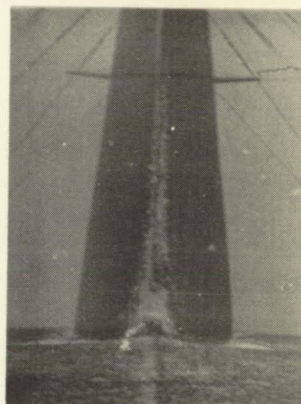
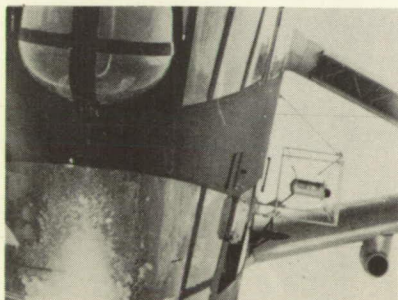
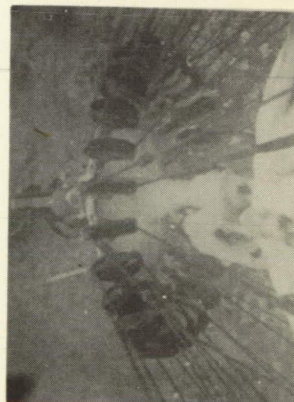
At about 3:10 p. m. (fig. 23 - cameras 2, 6, 8, and 9) ice started forming at a more rapid rate on the control and brace wires at the tail, on the fin leading edge, and on the car window. Thirty minutes later ice and impacted snow have continued to build up as

Figure 23.- Condition of the K-24 airship envelope, fins, and car at 3:10 p. m., Mar. 22, 1945.

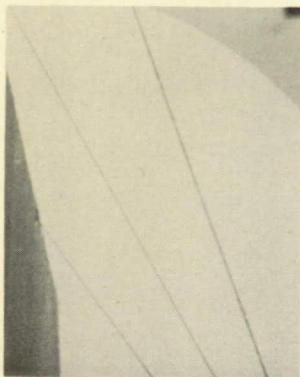
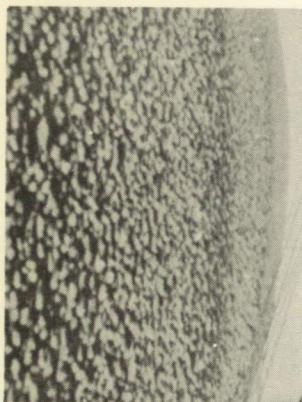
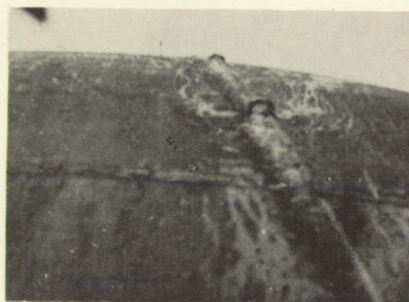
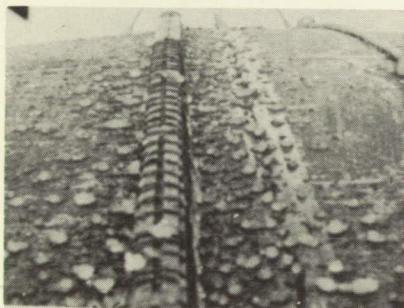
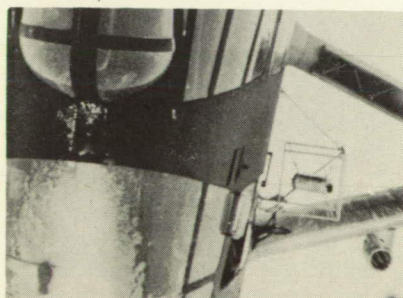
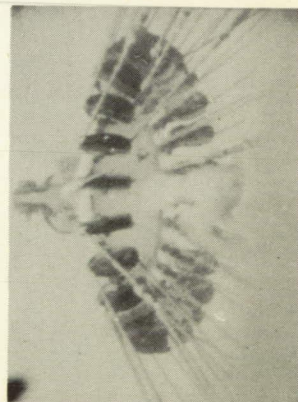
shown in figure 24. Very little snow remained on the envelope except at the bow and stern. The haze over a portion of the record of camera 12 is ice in the opening of the camera fairing. After 700 pounds of sand were jettisoned the airship was flying with 5° down-elevator and 2° up-inclination. Views of ice on the engine outrigger, spotlight, aerograph, and open airscoop are shown in figures 25, 26, 27, and 28.

Figure 24.-- Condition of the K-24 airship envelope, fins, and car at 3:40 p. m., Mar. 22, 1945.

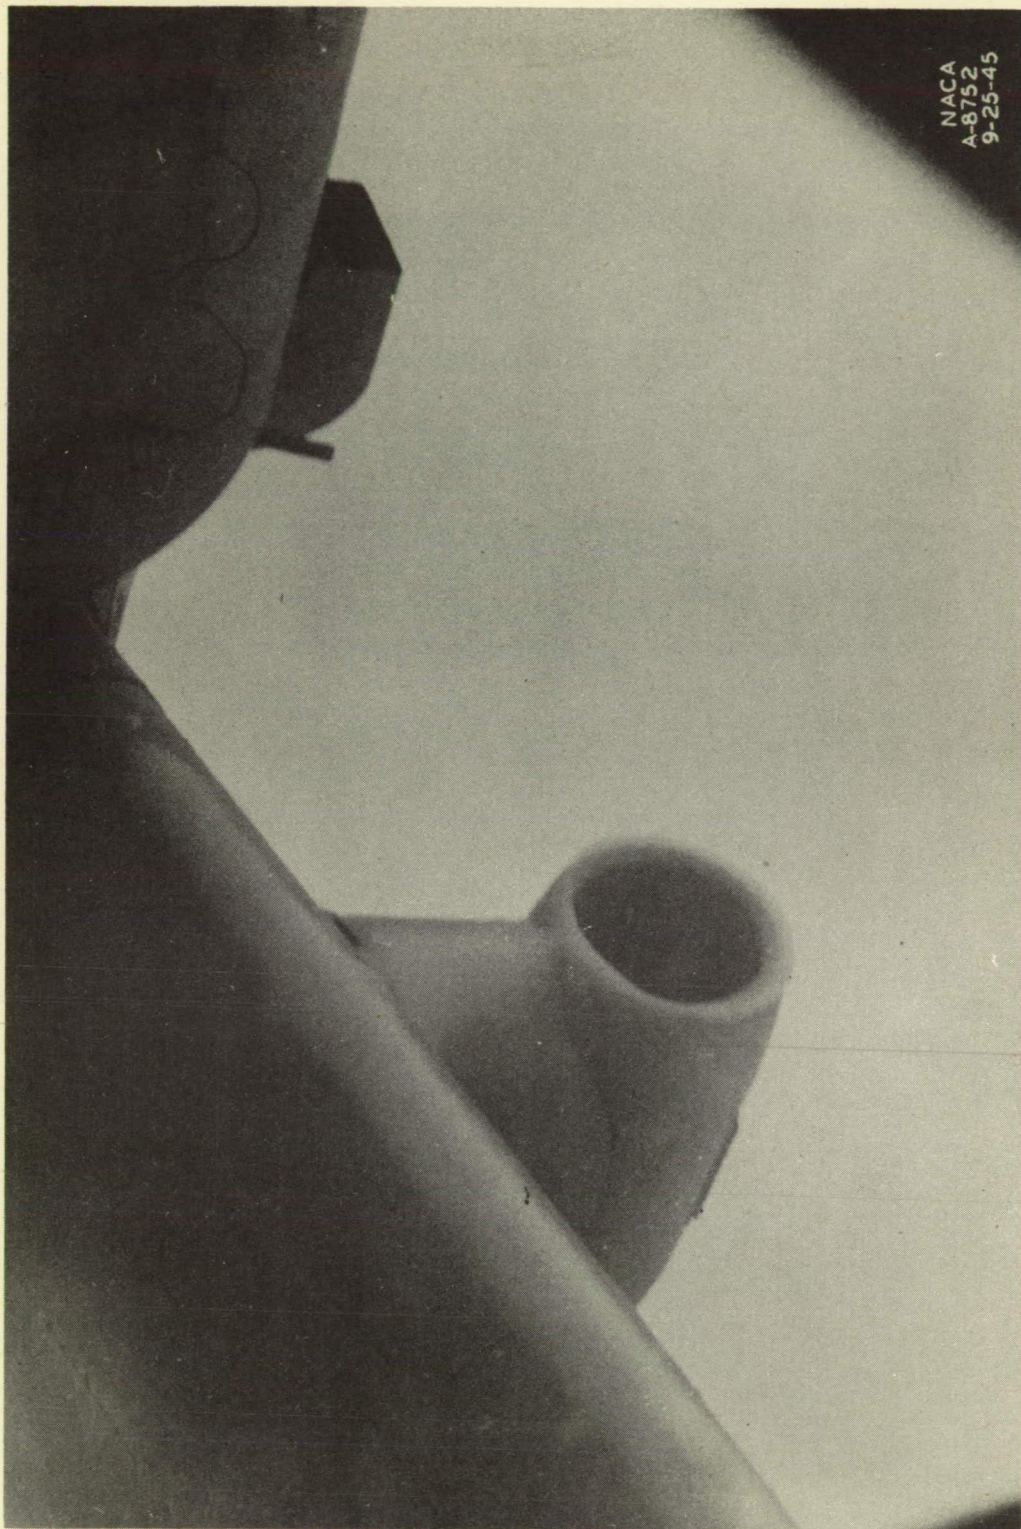
Figure 25.- Ice on the K-24 airship port outrigger at 3:45 p. m., Mar. 22, 1945.

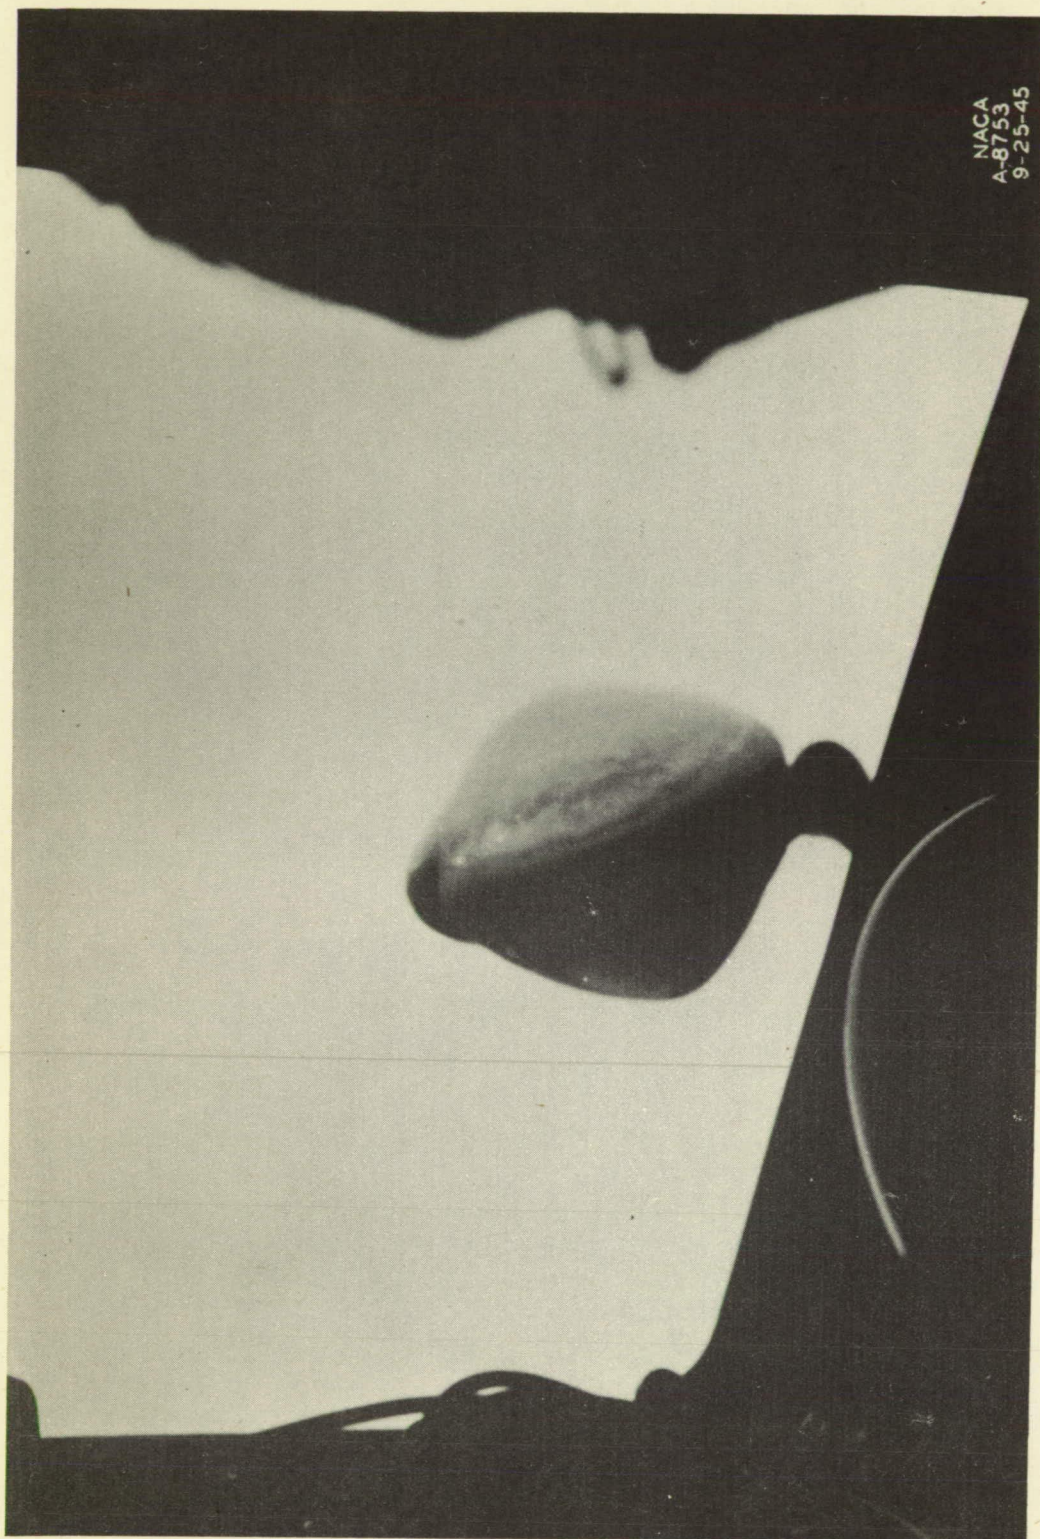
Figure 26.- Ice on the K-24 airship spotlight at the rudderman's window at 3:45 p. m.,
Mar. 22, 1945.

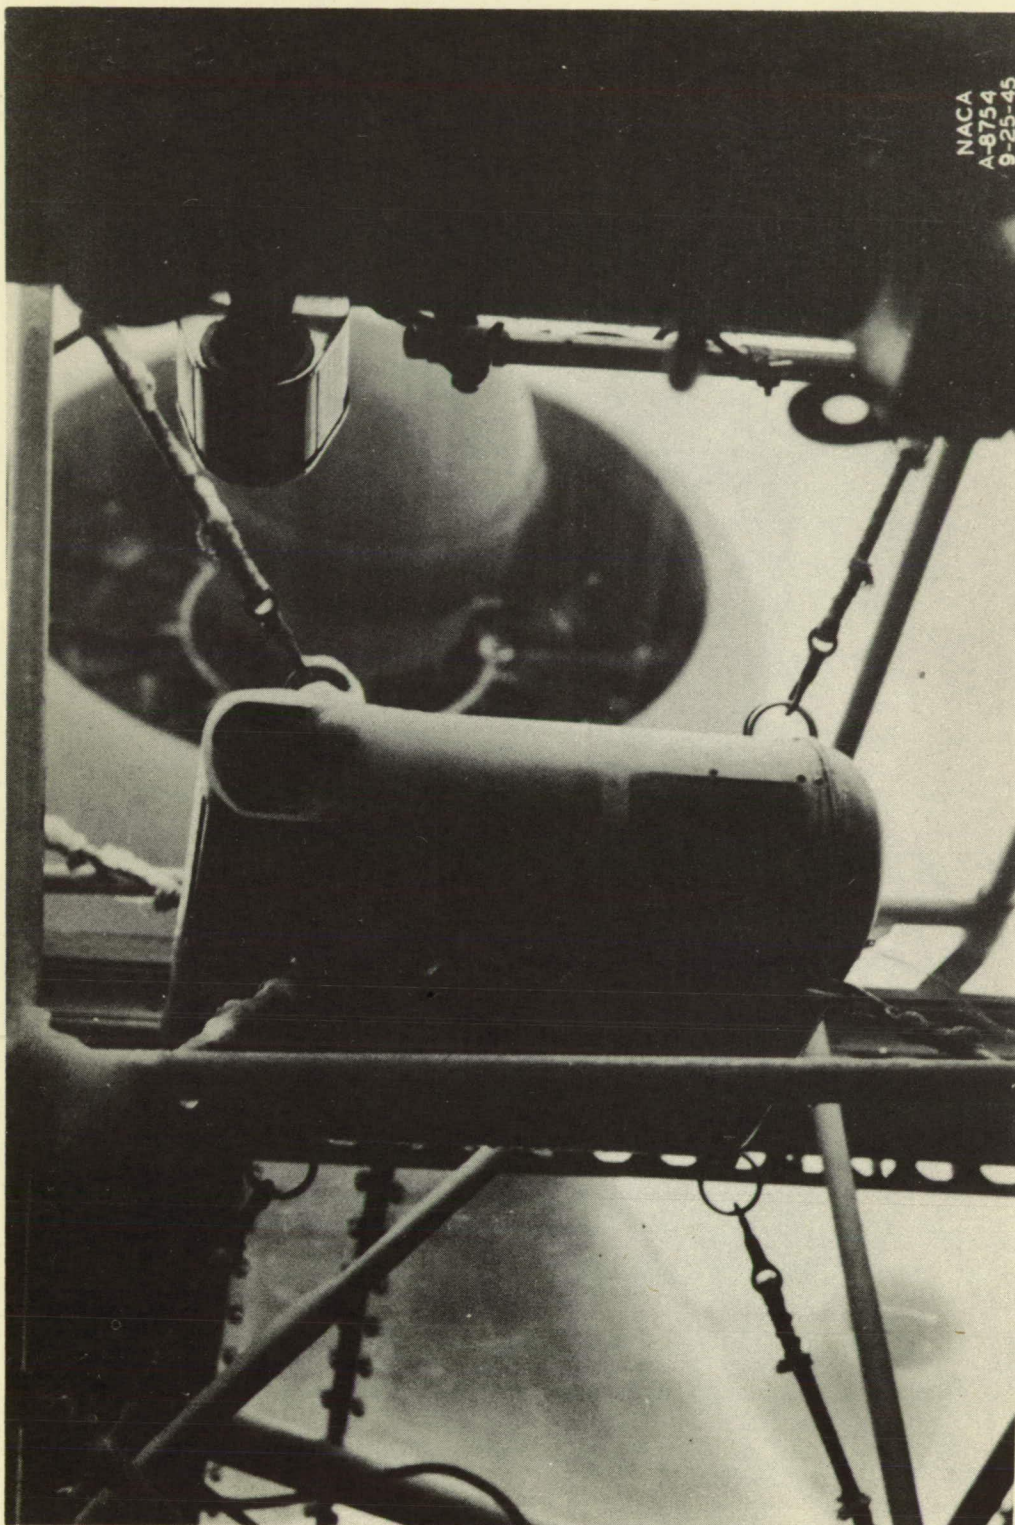
Figure 27.- Ice on the aerograph at 3:50 p. m., Mar. 22, 1945. (Frame swung inside car.)

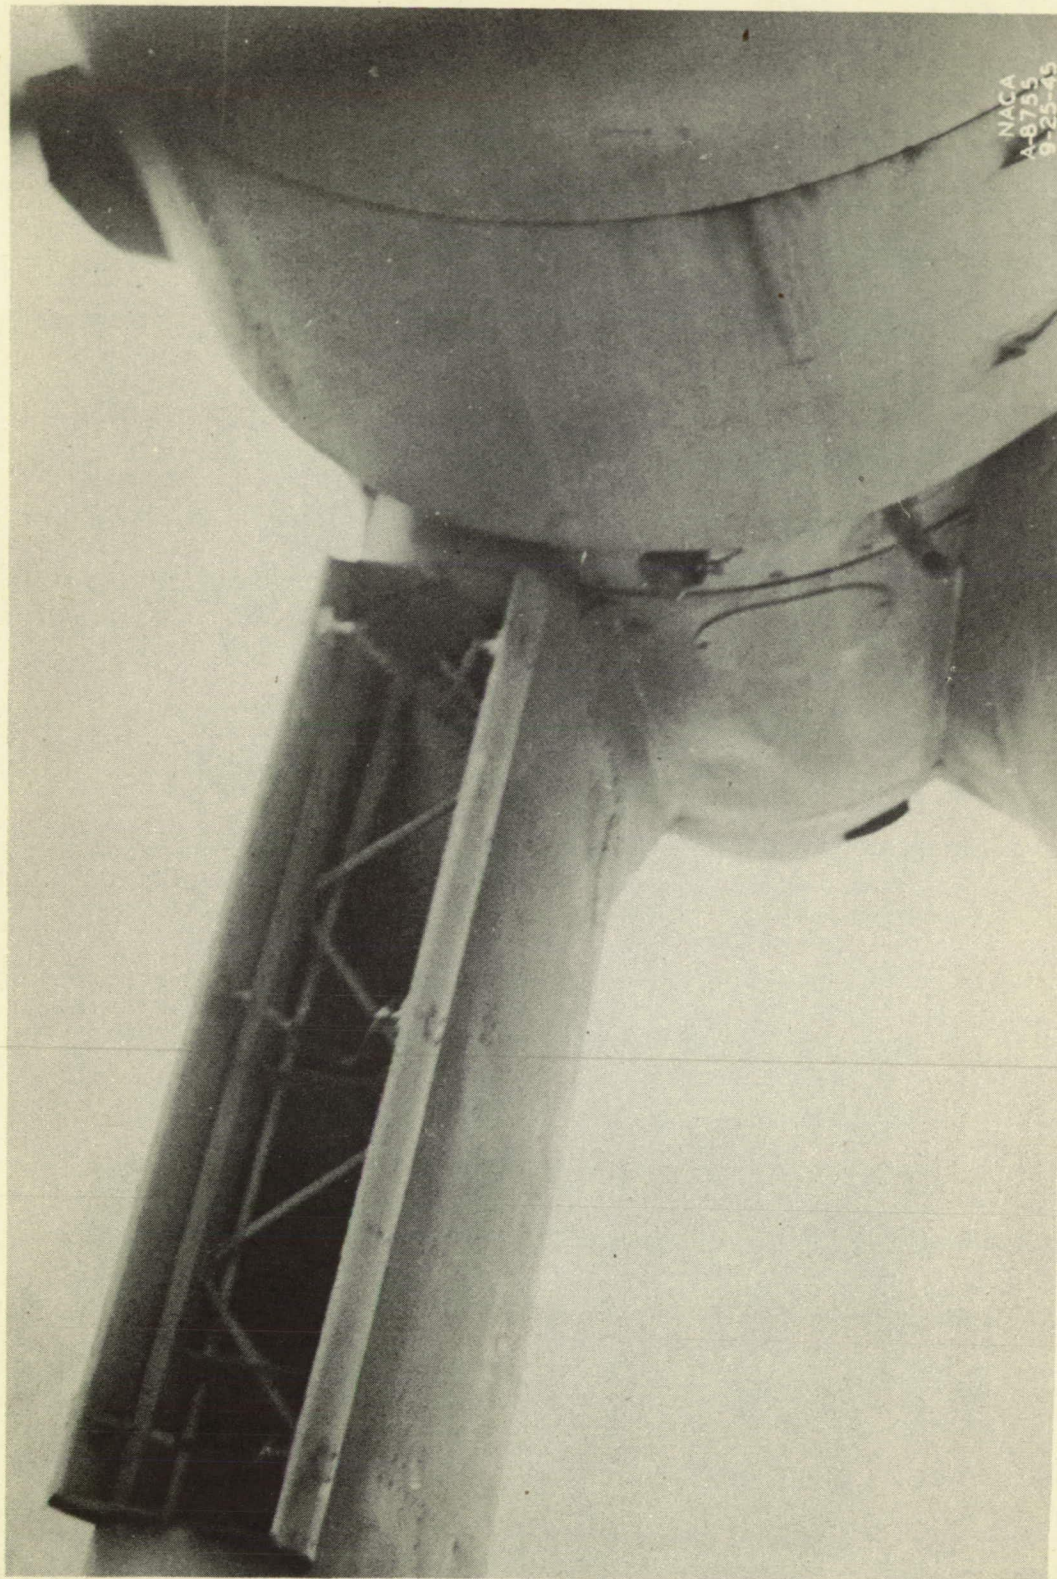
Figure 28.- Ice on the K-24 airship port air scoop at 3:55 p. m., Mar. 22, 1945.

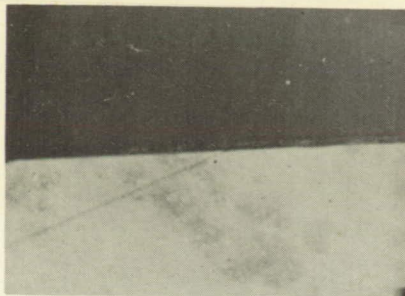
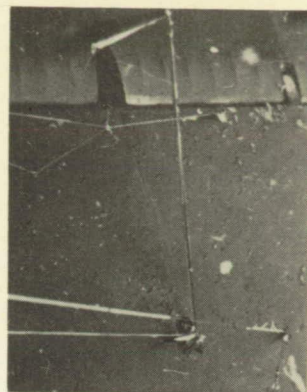
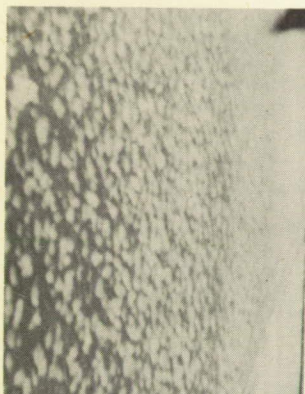
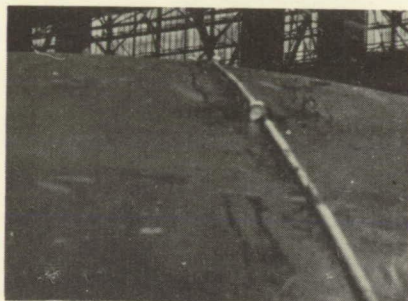
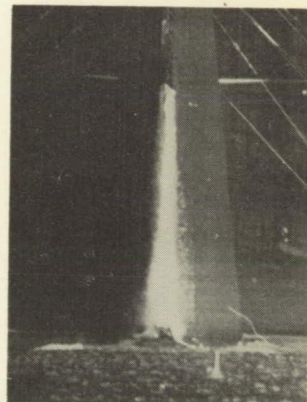
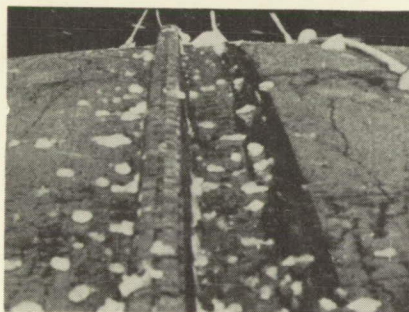
At 4:05 p.m. 200 gallons of gasoline were jettisoned preparatory for landing. The airship landed at 4:10 p.m., about 200 pounds light. The camera records shown in figure 29 were made upon entering the hangar. The heavy accumulation of snow and ice shown on the stern by camera 1 persisted throughout the flight. The records of the cameras scanning other parts of the envelope show most of the snow to have melted or blown off.

Figure 29.- Condition of the K-24 airship envelope, fins, and car after landing at 4:10 p. m., Mar. 22, 1945.

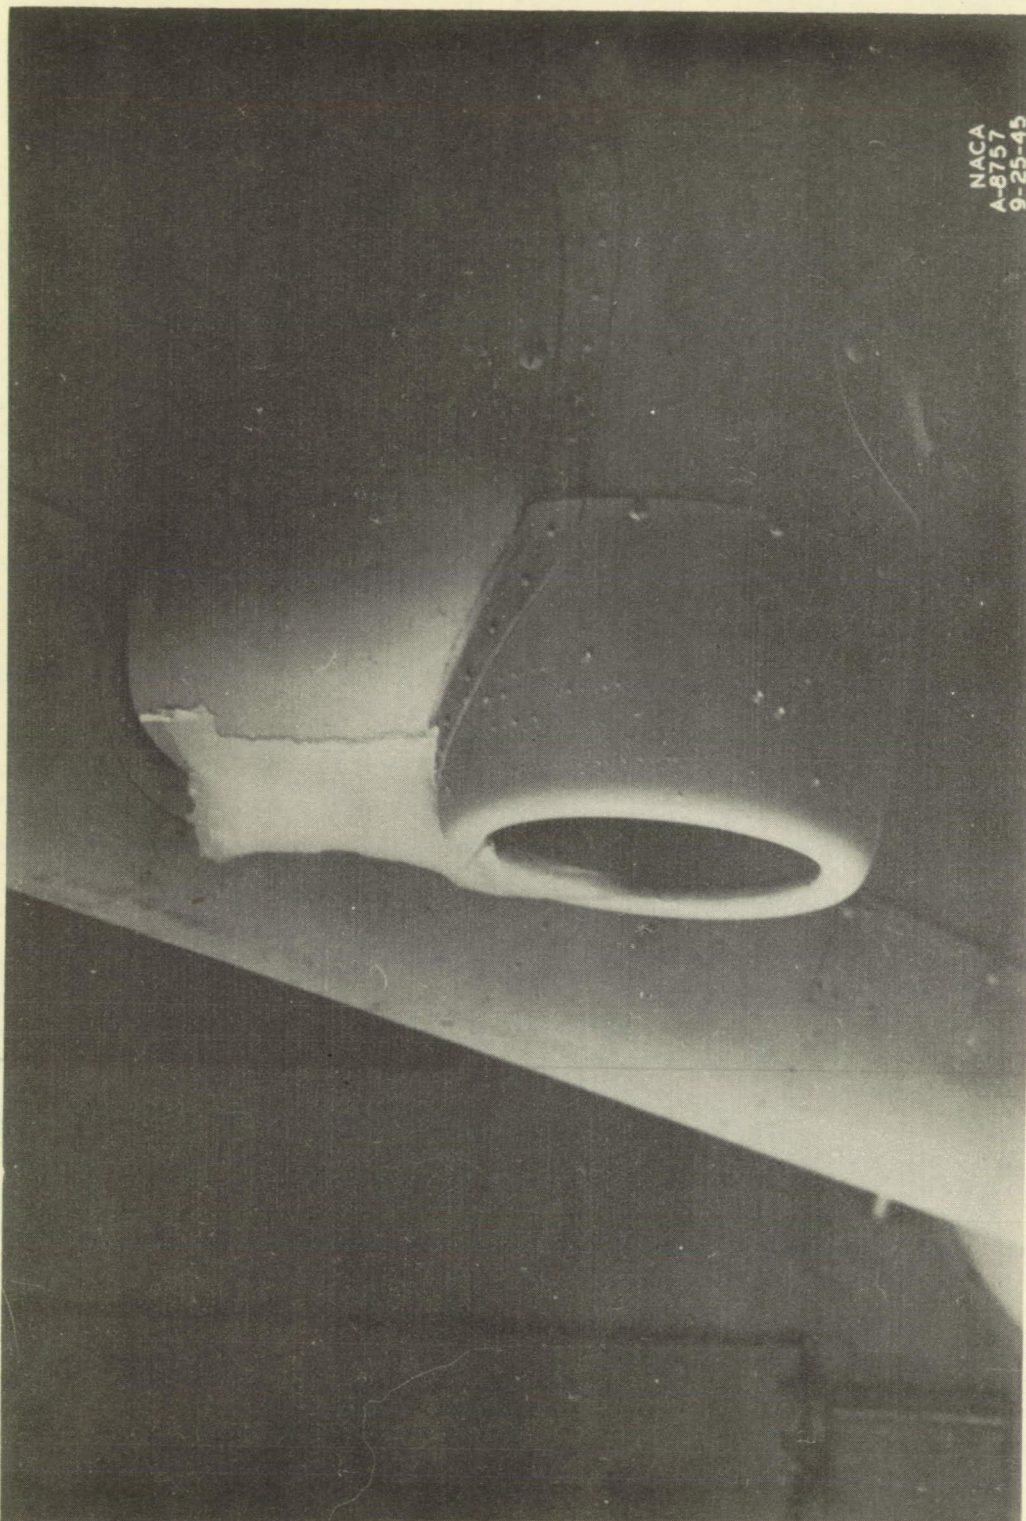
The following pictures were taken while the K-24 was being docked. Figure 30 shows the thickness of the ice which had accumulated on the oil-cooler strut. The ice remaining on the car windshield, spotlight, and electric humidity transmitter can be seen in figure 31. Figures 32, 33, and 34 show the snow remaining on the bow and stern of the envelope and on the upper fin brace wires. Figure 35 shows the general clear appearance of the envelope immediately after landing.

Figure 30.- Close-up of ice on the K-24 airship port oil-cooler strut after landing, Mar. 22, 1945.

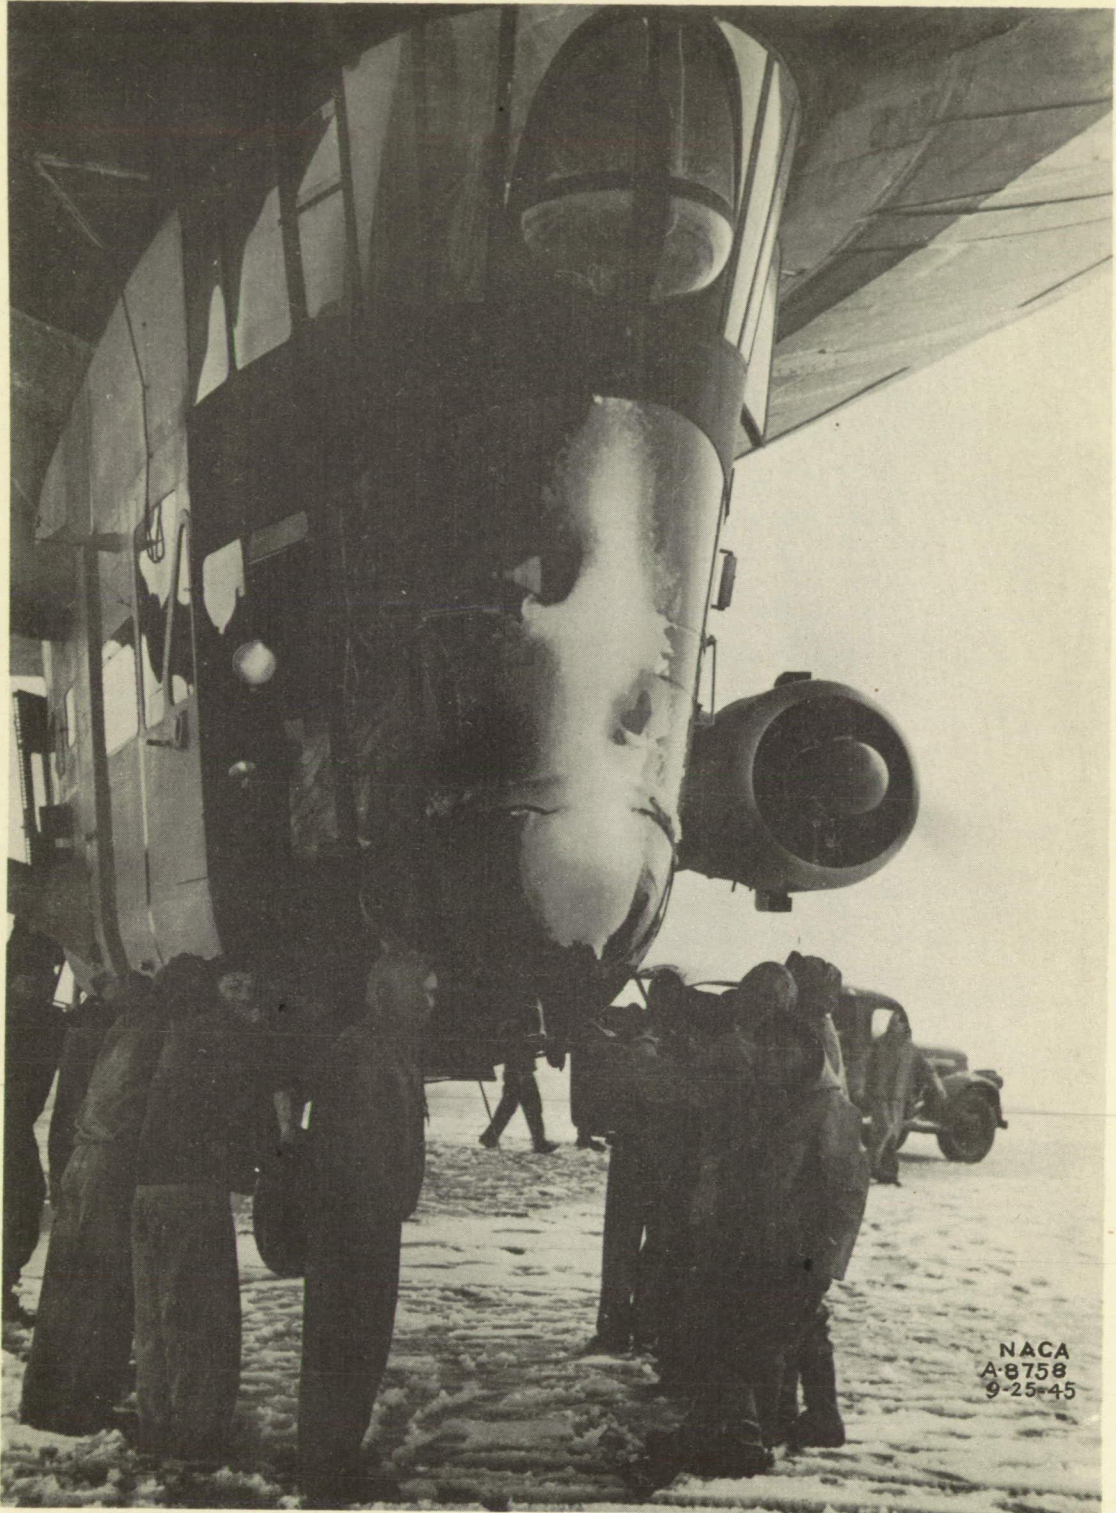
Figure 31.- Residual ice on the front of the K-24 airship car, spotlight, and humidity transmitter after landing, Mar. 22, 1945.

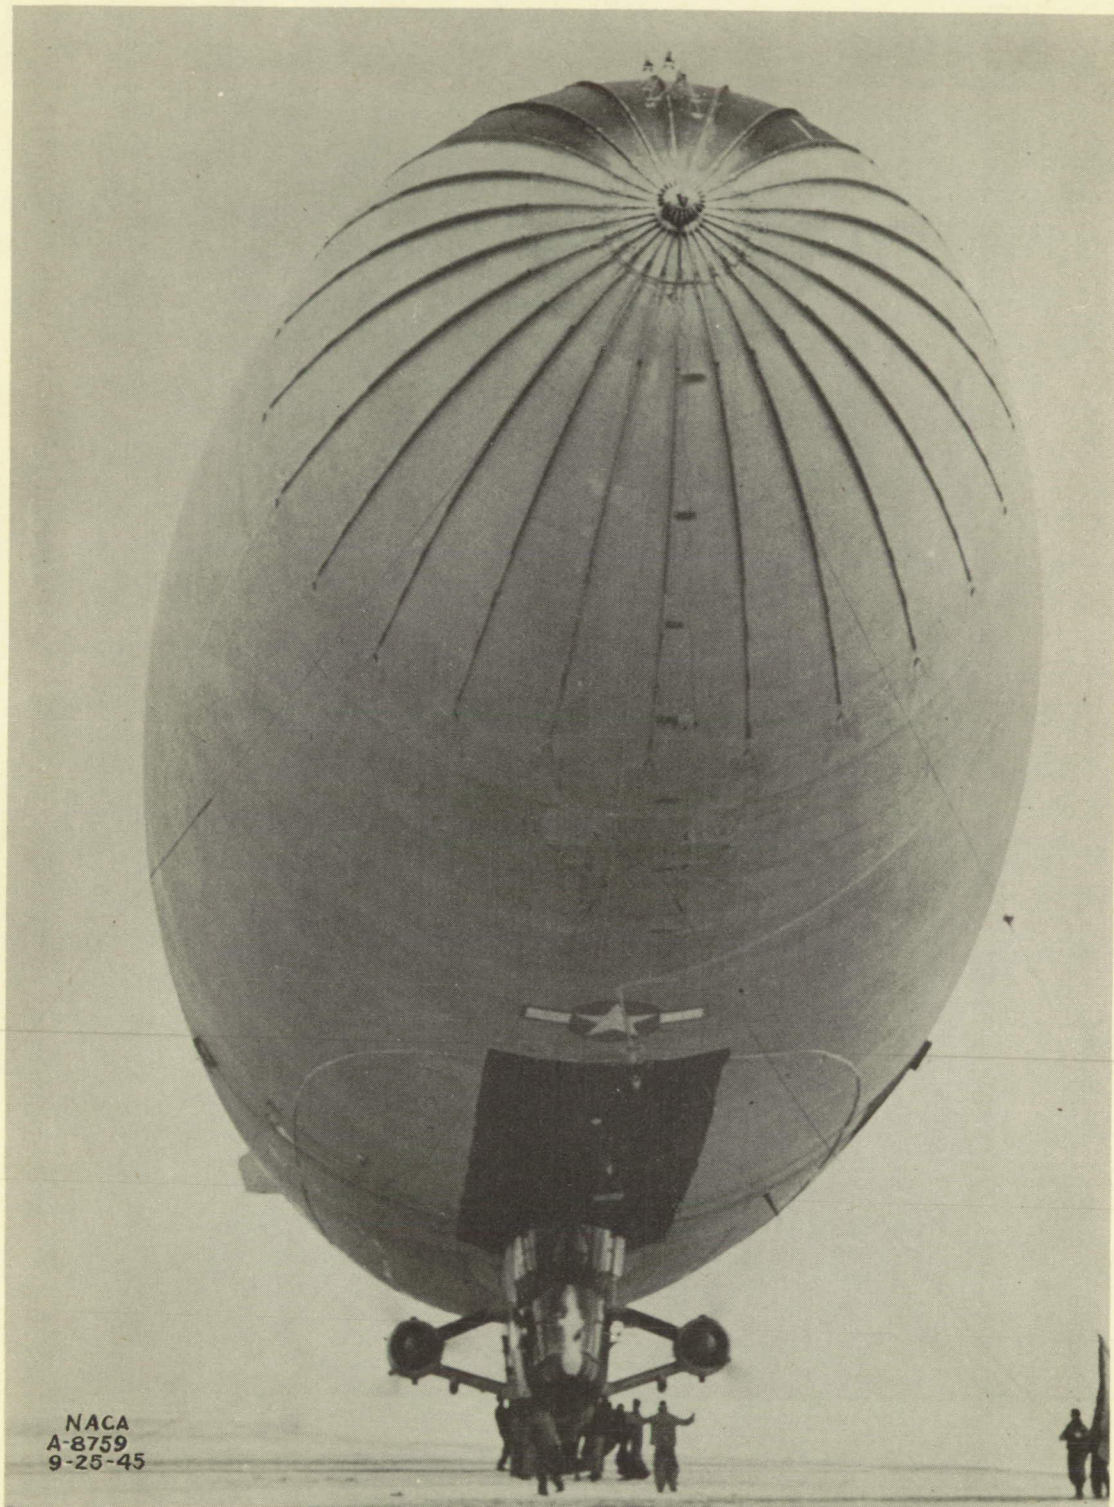
Figure 32.- Residual ice and snow on the bow of the K-24 airship after landing, Mar. 22, 1945.

4. While ice and snow accumulate at the bow and stern of the envelope during flight, the present tests indicate that ice-prevention equipment is desirable but not essential in these regions when flying in wet snow.
